NIST NCSTAR 1-2B

**Federal Building and Fire Safety Investigation of the
World Trade Center Disaster**

**Analysis of Aircraft Impacts into the
World Trade Center Towers
Chapters 9, 10, 11 & Appendix A**

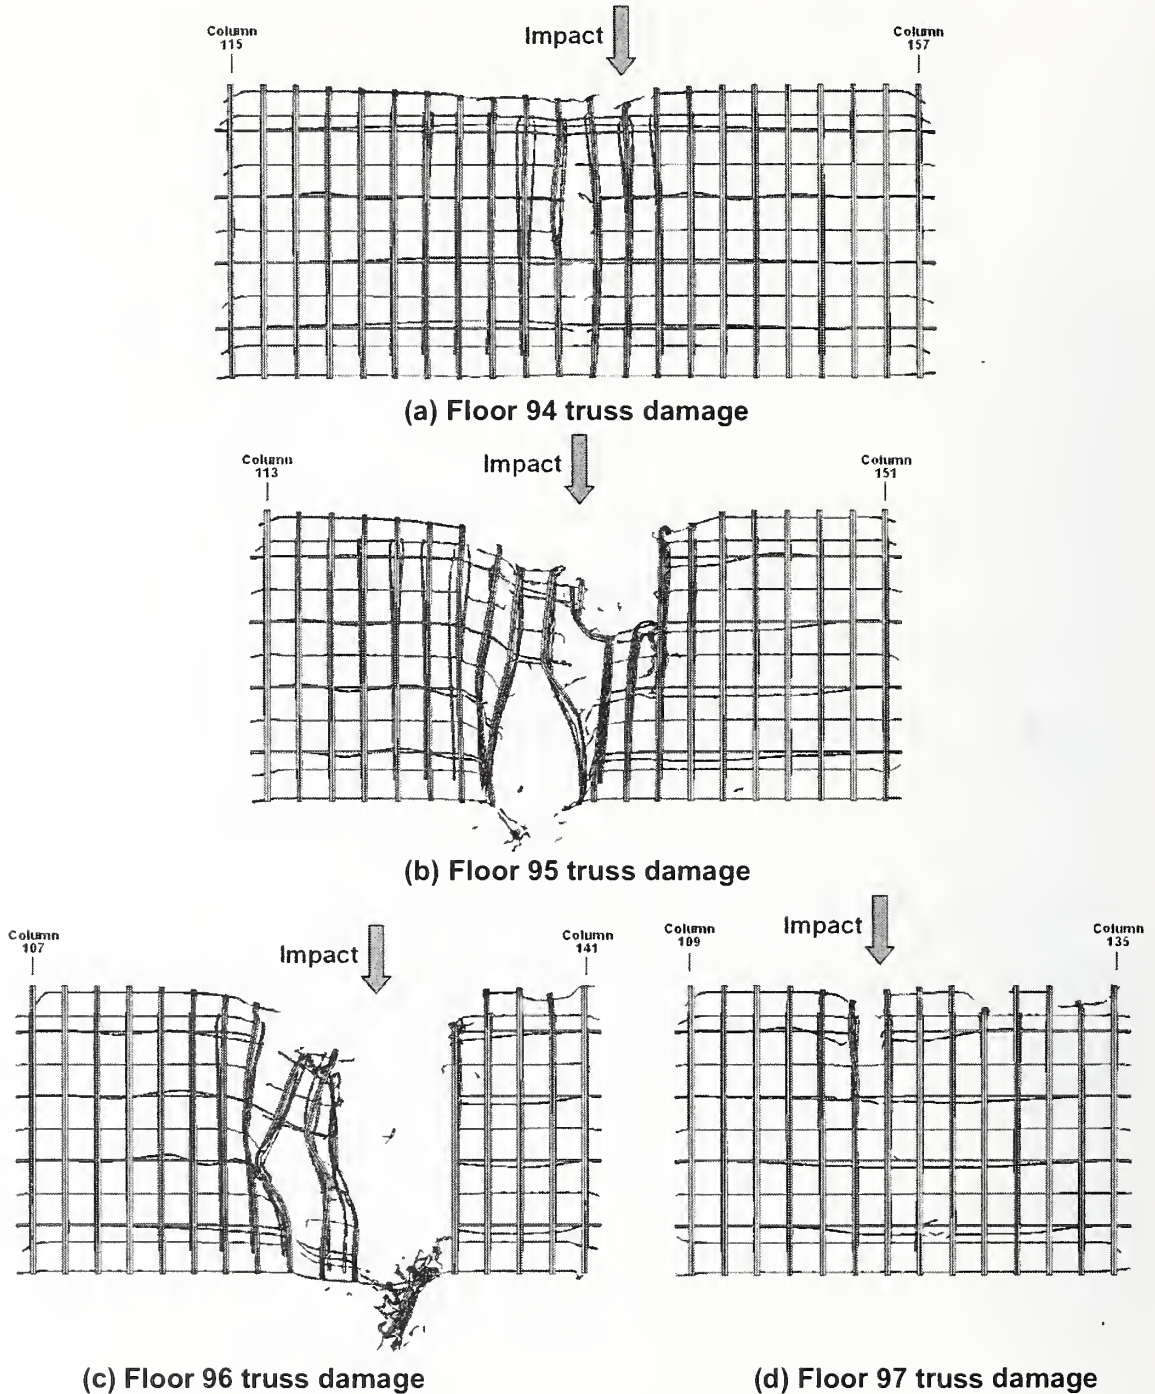
Figure 9–68. Less severe impact damage to the WTC 1 floor truss (plan view).

The magnitude of truss floor damage was very similar for the base case and more severe global impact analyses. When the floor-by-floor damage was compared for the base case and less severe impact analyses, Figure 9-15 and Figure 9-68, respectively, the damage was slightly increased for the less severe impact analysis. The parameters used in the less severe global impact analysis would primarily contribute to a reduced damage magnitude for the tower structures. However, the downward impact trajectory angle was increased from the 10.6 degree angle in the base case analysis to a 13.6 degree angle in the more severe impact analysis. This would have the effect of directing more of the impact energy downward, increasing the normal force on the floor structures in the impact zone. As a result, the combined effects of the analysis parameter variations produced a small increase in the damage to the truss structure in the less severe impact analysis scenario.
